POPPLETON HISTORIC STUDY

1100 W. Fairmount Avenue

1064-1082 W. Fairmount Avenue.

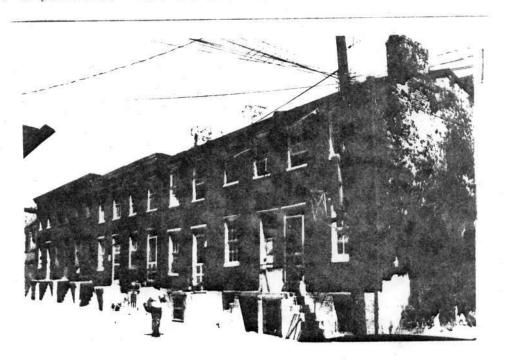
B-2583 1064-1082 & 1100 W. Fairmount Avenue (1064-1082 Demolished)

The group is perhaps late 19th century workers' housing for the mill. Numbers 1062-1066 have gable roofs; the others are flat with cornices. All have 6/6 windows and cellar entrances. Number 1082, probably a former stable, is presently used as a garage.

This is a quiet pleasant back street with all good houses recently removed from its south side; the rear of the theater and 3 garages plus empty lots are the view across the street. Has potential as quiet residential, but redesign of Baltimore Street will be more important. Lot at 1064 is cleared.

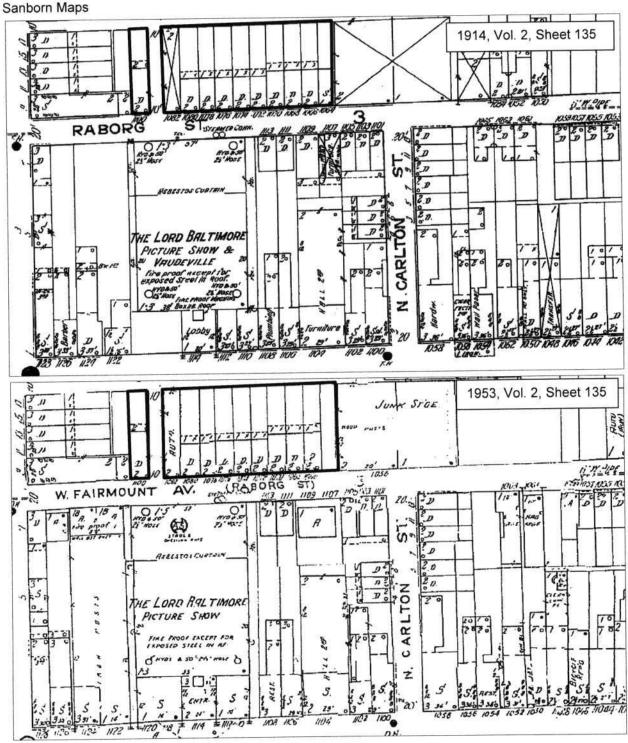
B-2583 1064-1082 & 1100 W. Fairmount Avenue (1064-1082 Demolished) Block 0200, Lots 111-122 Baltimore City

Photo below shows floor joists laid directly on ground at llll W. Fairmount Avenue, where demolition took place during course of this survey.
